Monthly Oversight Report 29
ACS NPL Site
Griffith, Indiana
May 3, 2003 - May 30, 2003

Subject: Monthly Oversight Summary Report
No. 29 for May 2003

Monthly Oversight Summary Report No. 29
ACS Superfund Site WA57, 46526.238

Reporting Period: Month of May (May 2, 2003 - May 30, 2003)

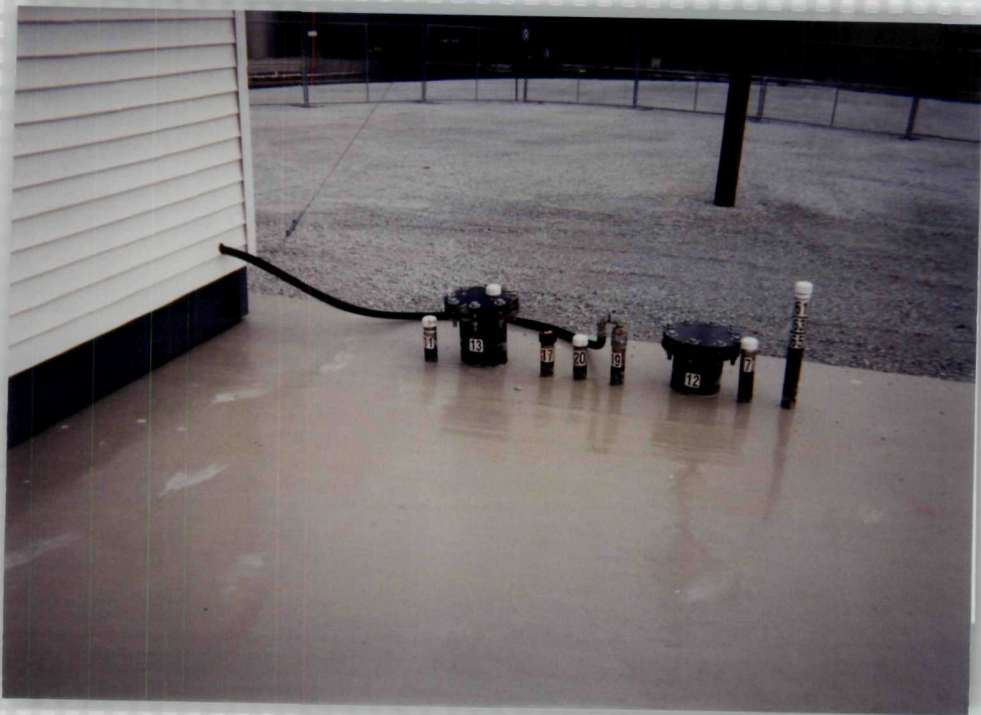
Site: American Chemical Services, Inc.
 Proj. # 46526
 Roll: 41 Photo #27
 Date: 05-28-03 Time: 09:10
 Photographer: Leigh Peters
 Description: Photo facing northeast showing SVE-46 and AS-1 that are awaiting backfill and concrete pad installation.

- needs gravel cover, concrete pad
- 0905 Observed 1-inch-diameter HDPE pipe extending from backfill at SVE 50. Air line to well is connected - to ask MWH purpose of extended HDPE line. Also observed SVE 46 and adjacent air sparge point not backfilled with gravel and in need of concrete pads to be installed by IES.

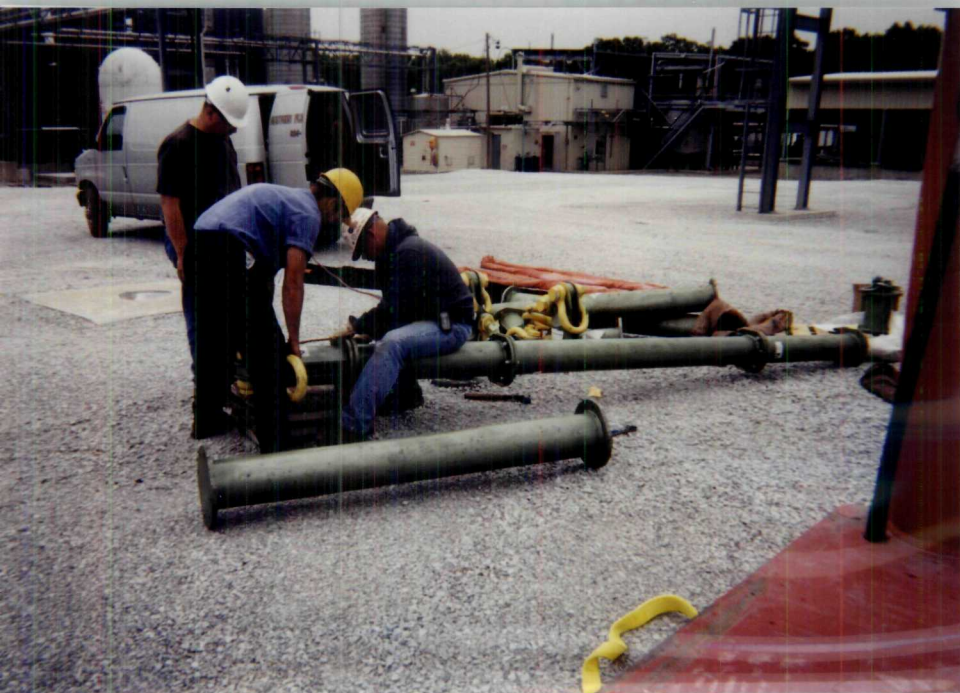
Description: Photo facing east showing Central Crane on ONCA SBPA unloading equipment for the crane lift of ONCA SBPA ISVE system blower shed building #1.

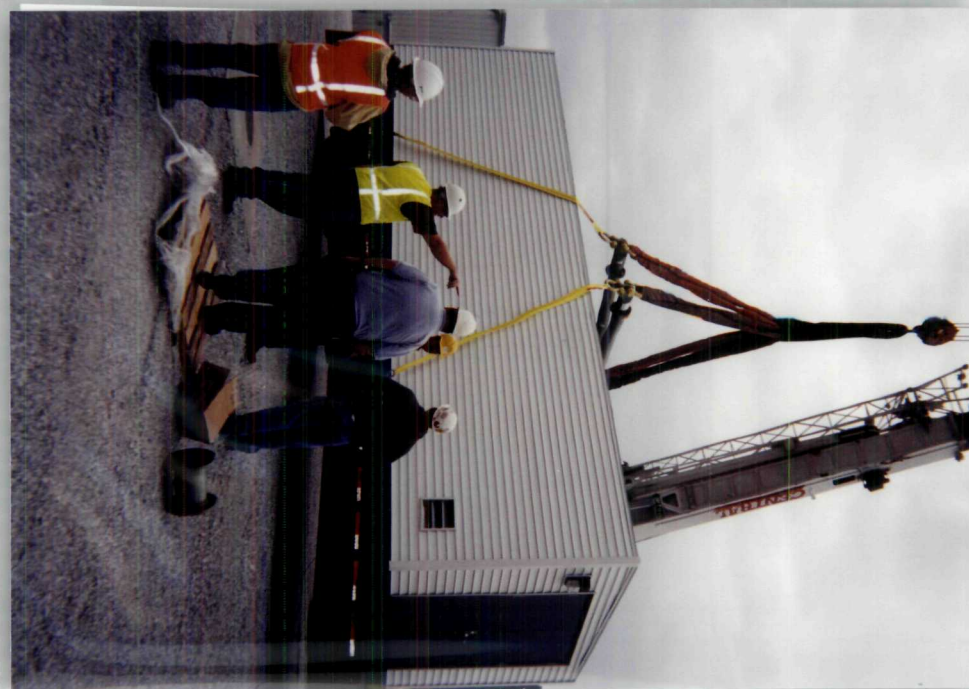
Site: American Chemical Services, Inc.
 Proj. #: 46526
 Roll: 42 Photo #3
 Date: 05-28-03 Time: 11:30
 Photographer: Leigh Peters
 Description: Photo facing northeast showing Austgen and Central Crane setting up the rigging for the crane lift.

- 1130 Roll 42 Photo 3 facing NE showing Austgen and Hammond crane setting up rigging.
- 1215 - 1300 Left site for lunch. Returned and worked on Weekly reports.

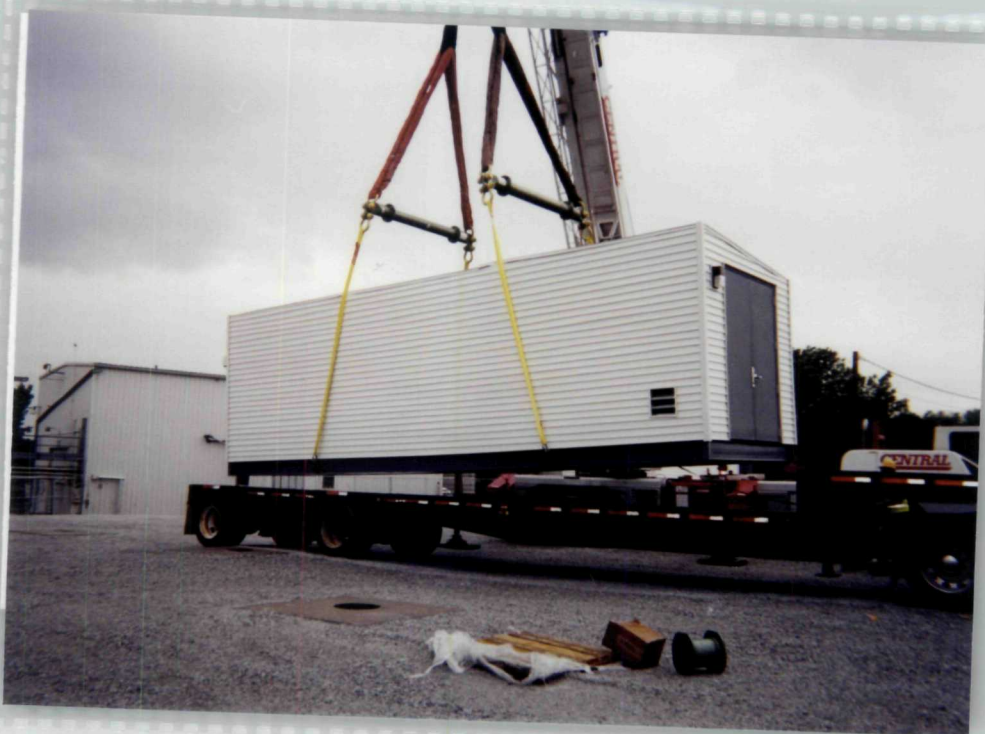
Site: American Chemical Services, Inc.
 Proj. #: 46526
 Roll: 42 Photo #4
 Date: 05-28-03 Time: 13:45
 Photographer: Leigh Peters
 Description: Photo facing southwest showing the rigging from the crane to lift ONCA SBPA ISVE system blower shed building #1.

- 1330 Went to ONCA for blower shed lift.
- 1345 Roll 42 Photo 4 facing SW of rigging from crane to new blower shed #1.
- 1350 Light rain started - MWH raised concern that rigging method may damage aluminum on top of shed. Flitway reported frame all still that isn't be damaged.

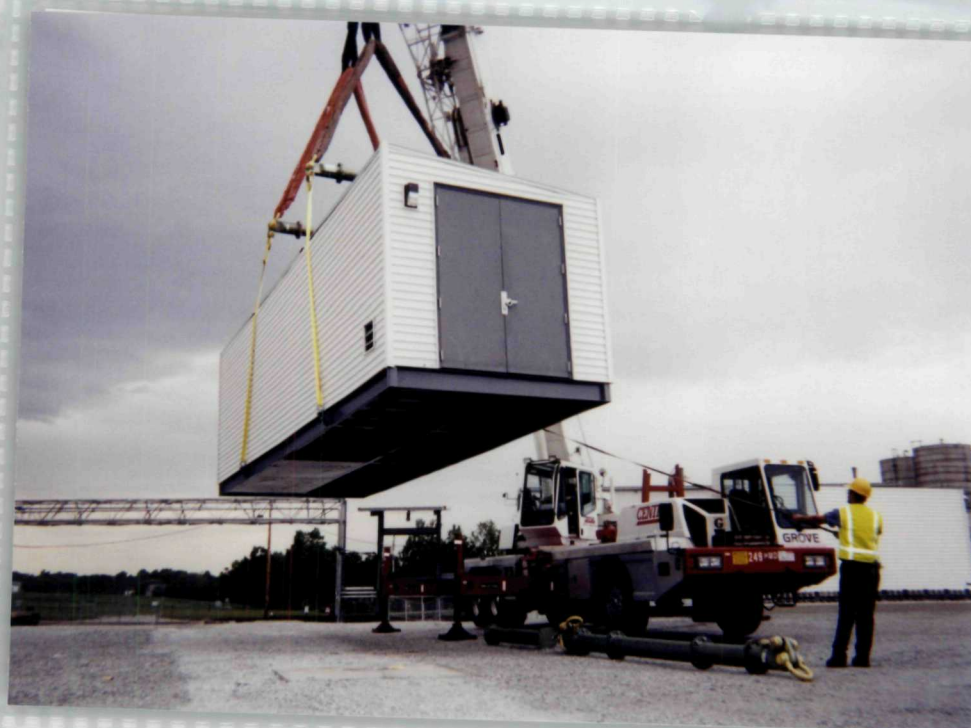
Site: American Chemical Services, Inc.
 Proj. #: 46526
 Roll: 42 Photo #6
 Date: 05-28-03 Time: 13:53
 Photographer: Leigh Peters
 Description: Photo facing south showing MWH
 moving the ONCA SBPA ISVE system
 blower shed building #1. Note openings
 in flooring for yard piping.

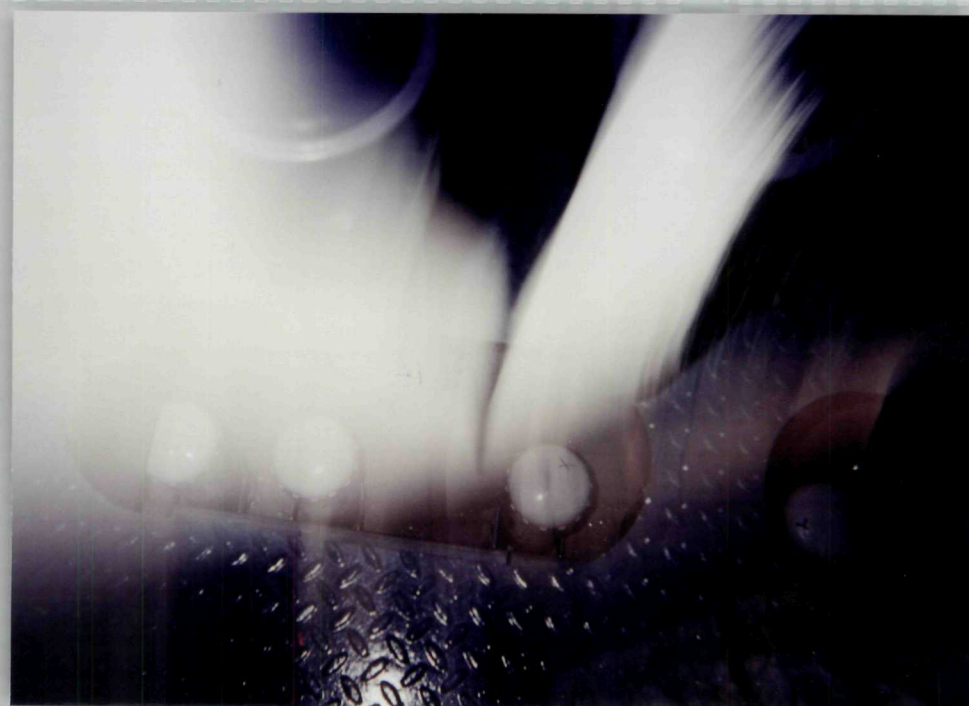
Description: Photo facing north at the ground of header, opening in floor and floor beams intersecting the vapor lines in blower shed building #1.
